## Humpback Creek Cable Splicing

Cordova Electric Cooperative September 21, 2004

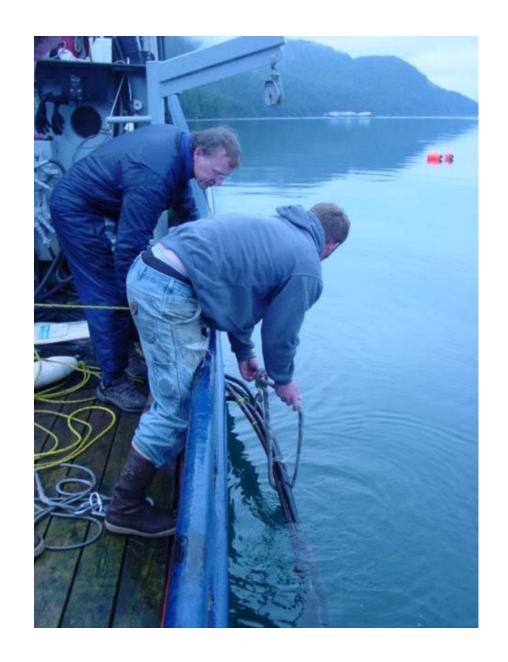
Bob Pudwill and Mark Heidbrink Dove to the existing cable splices, marked each side of the splices with different colored tie wraps, and cut the cables on the Humpback Creek (HBC) side of the splices. A buoy was attached to the end left in the water (background), and the cut ends lifted to the surface (foreground).

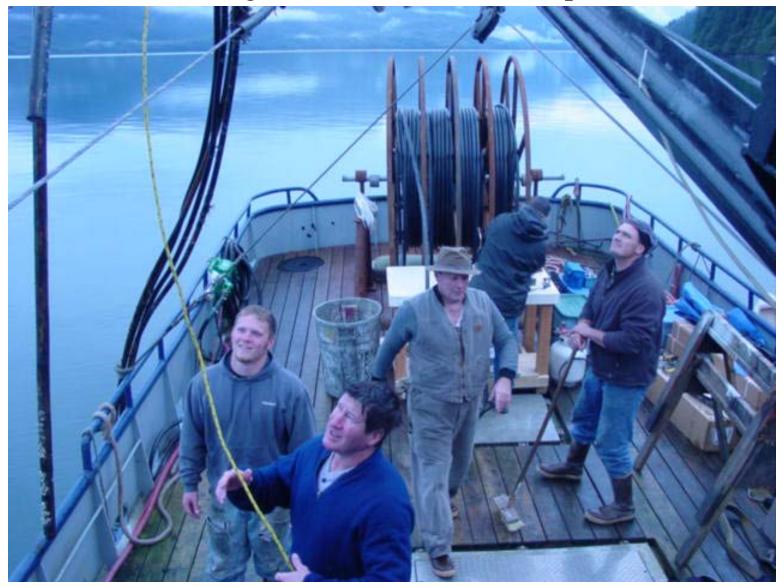
Situating wire for first series of splices

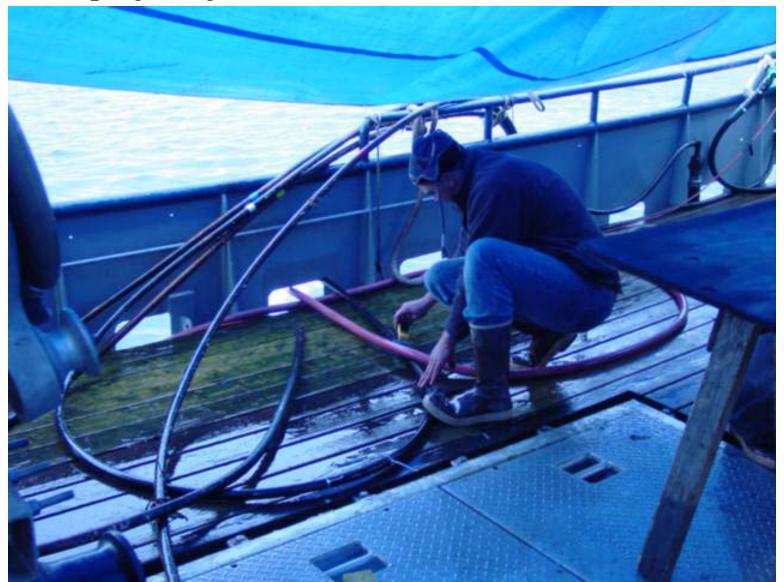
Scraping sea growth, barnacles, and rust from the cable

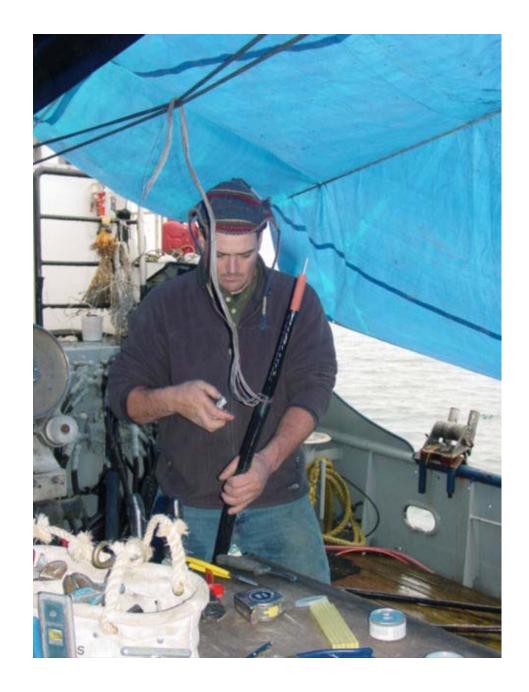
While one lineman is completing construction of the first splice, the rest of the crew is preparing the next set of cables for splicing. The cables are cut to length, the neutral left longer than the cable, the red insulation peeled back 1.75" to expose the bare, aluminum, 1/0 conductor. The insulation is sanded with non-conductive abrasive cloth to remove traces of semiconductor (black portion between red insulation and neutral tails).

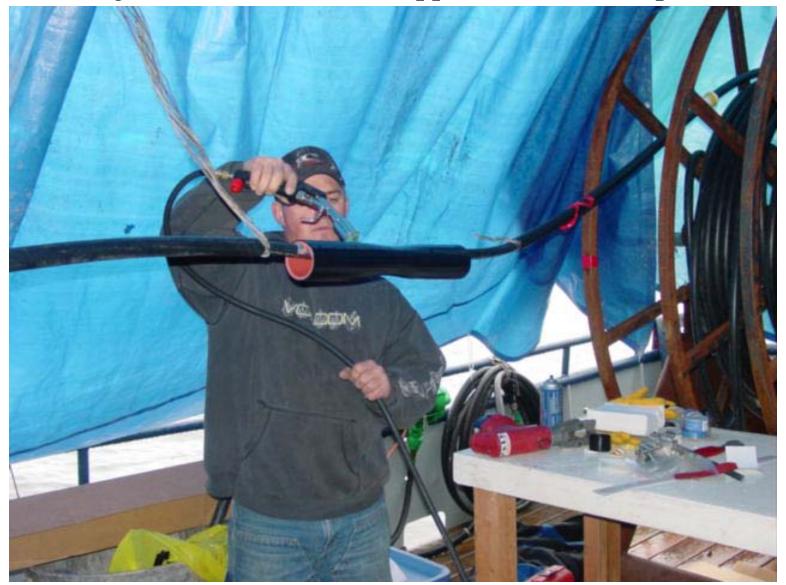
Large outer heat shrink is applied to the first splice

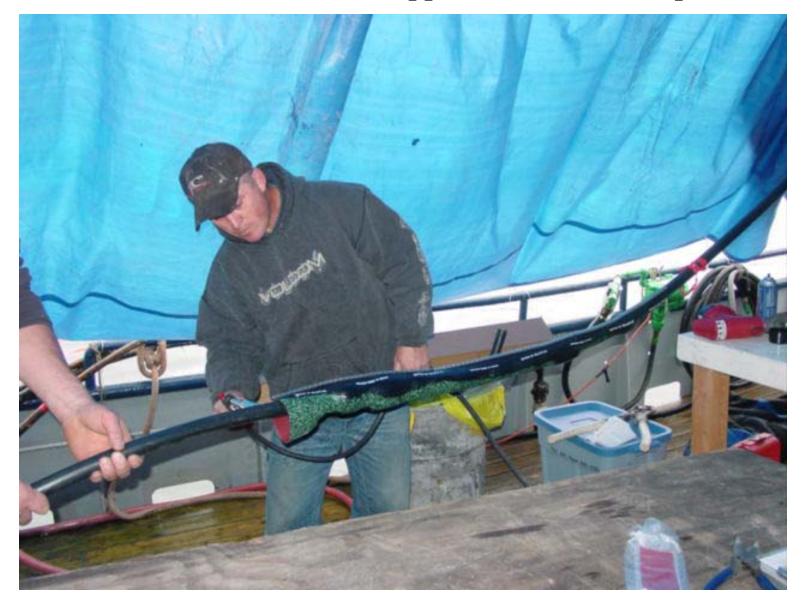
Final outer heat shrink is applied to the whole splice

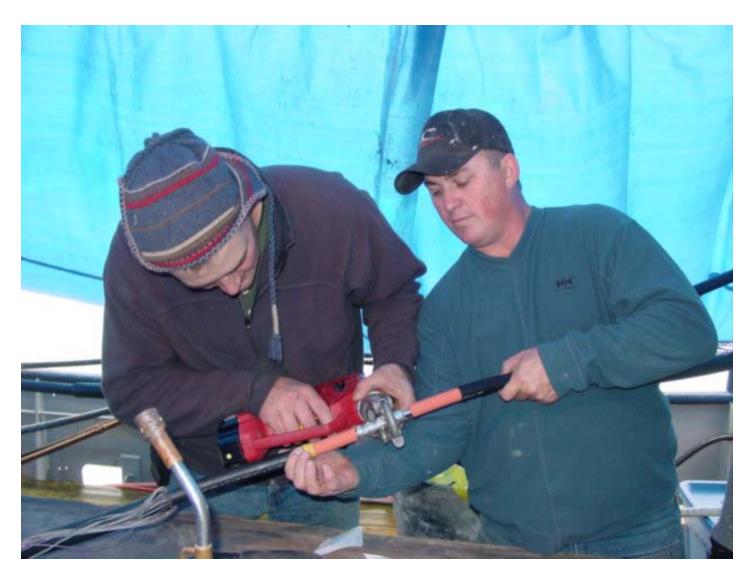
# The new cordless crimper is used to make quick, consistent, 7 ton connections

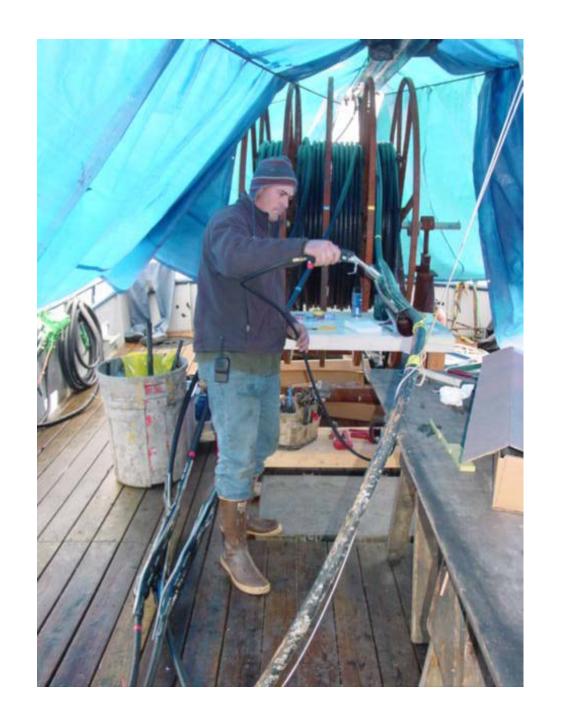
Outer heat shrink almost complete on splice 4. So far, three cables tested good back to HBC, and one tested bad. Either way, the splices have to be completed before day's end. Note the three completed splices on the deck. Each splice is allowed to cool before being lowered to the deck so that the outer heat shrink isn't stretched or stressed.

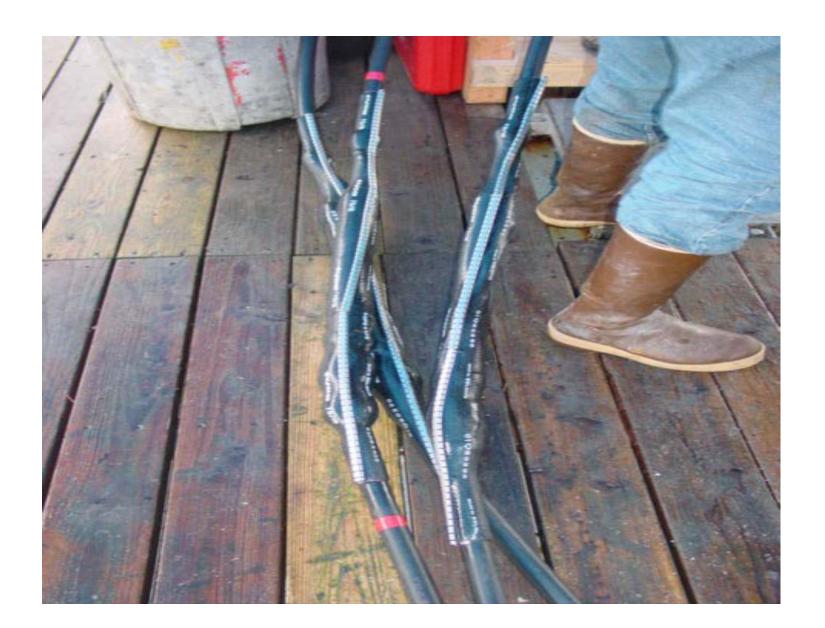
#### Picture stretched to illustrate the stainless steel "zipper"

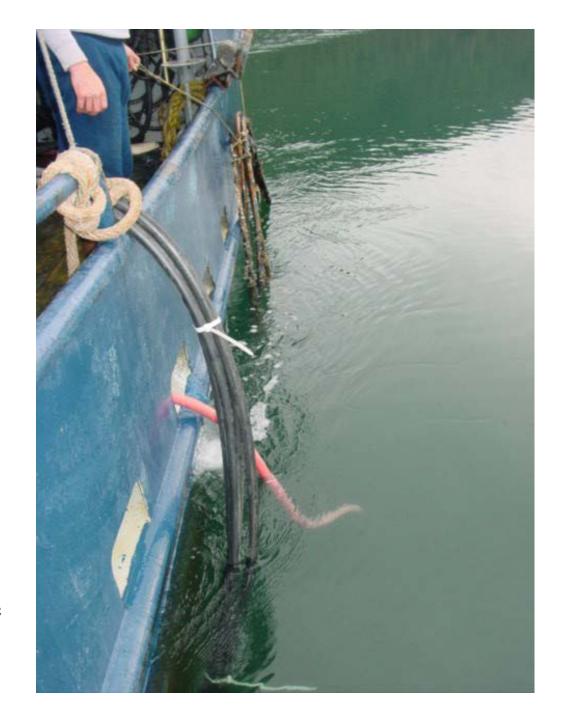
The other end of the cable is lifted to the surface. The first set of splices has been laid back in the water, and the boat has moved up the anchor line 75', paying out the new wire and tie wrapping it every 5-10'. The old splices will be cut out of the cable, and the new cable cut to length and spliced to the existing wire (town side of splices).

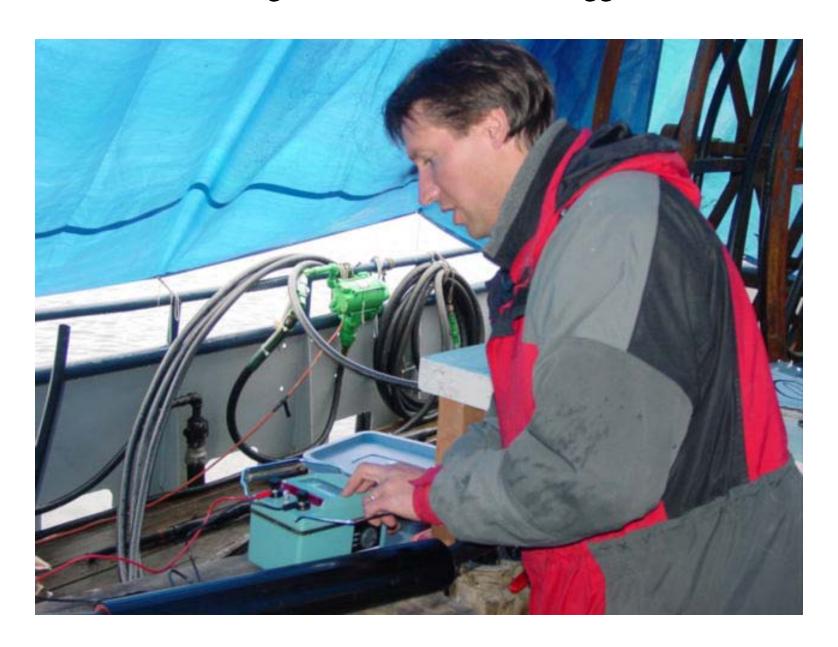
#### Testing each cable with the megger

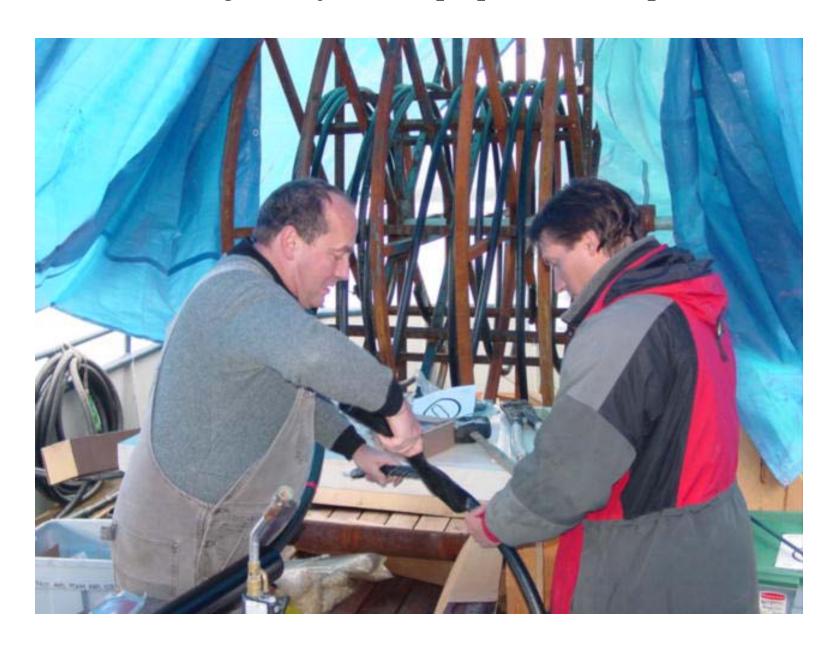
#### Removing outer jacket in preparation for splice 5

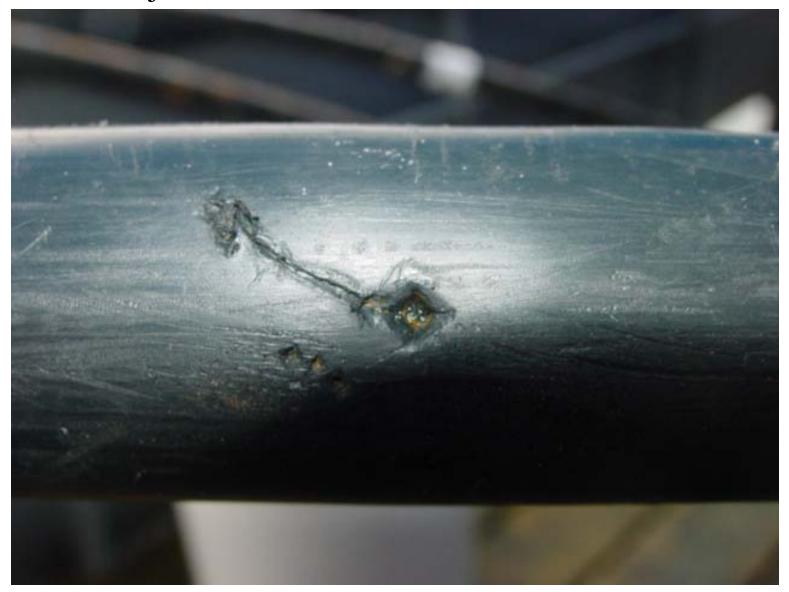
Damage is noted in one cable. The hole extends through the jacket and neutral into the semiconductor

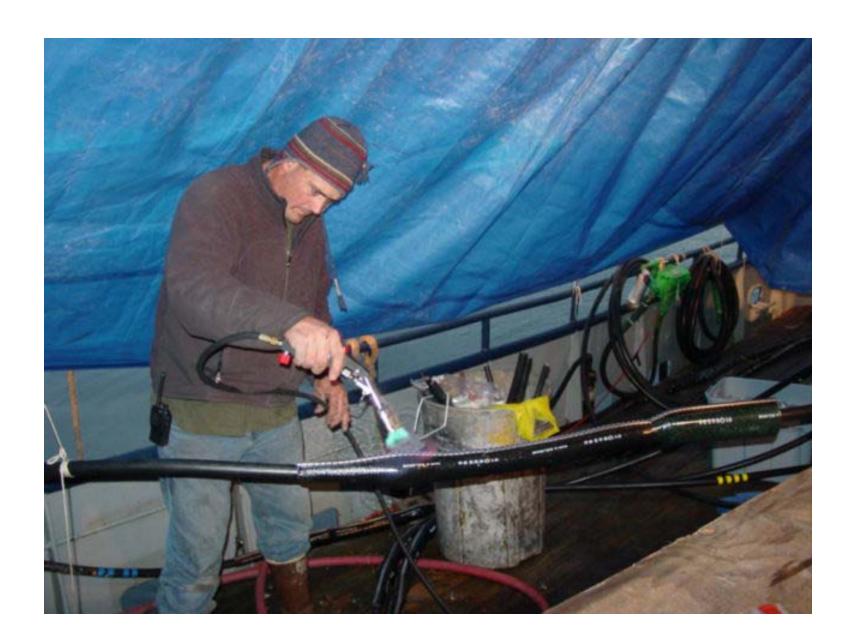
### The Eighth and final splice nears completion

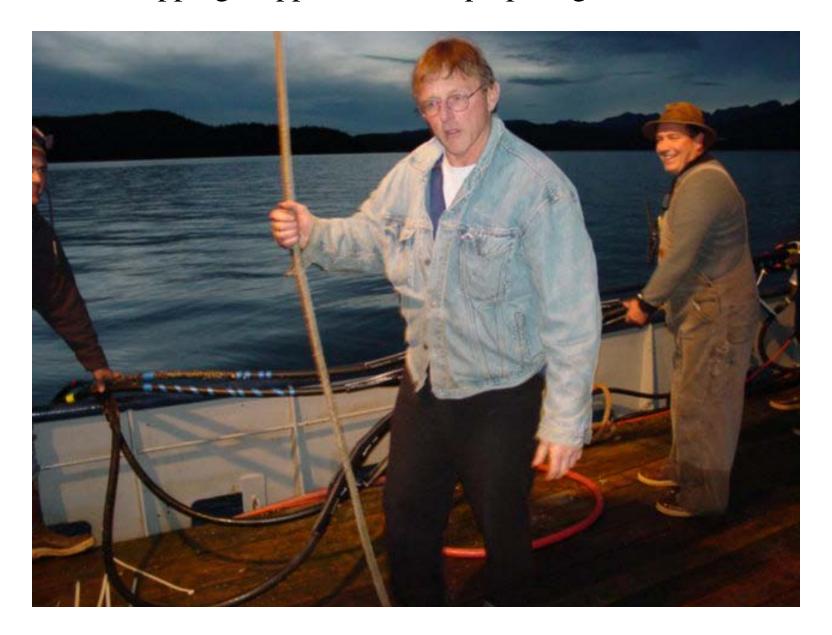
#### Good shipping skipper and crew preparing to lower cable
