Mitigation measures for Lake Sturgeon associated to new hydroelectric generating stations in the James Bay territory (Québec, Canada)

Frédéric Burton
Biologist and Project manager
Environnement Illimité inc.

Eastmain-1 Hydroelectric Development / Eastmain 1-A and La Sarcelle generating stations and Rupert Diversion

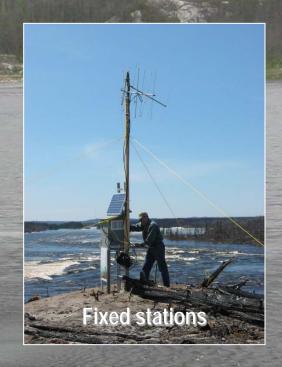
External radio transmitters for adults from 2002 to 2004

277 tagged Lake sturgeon

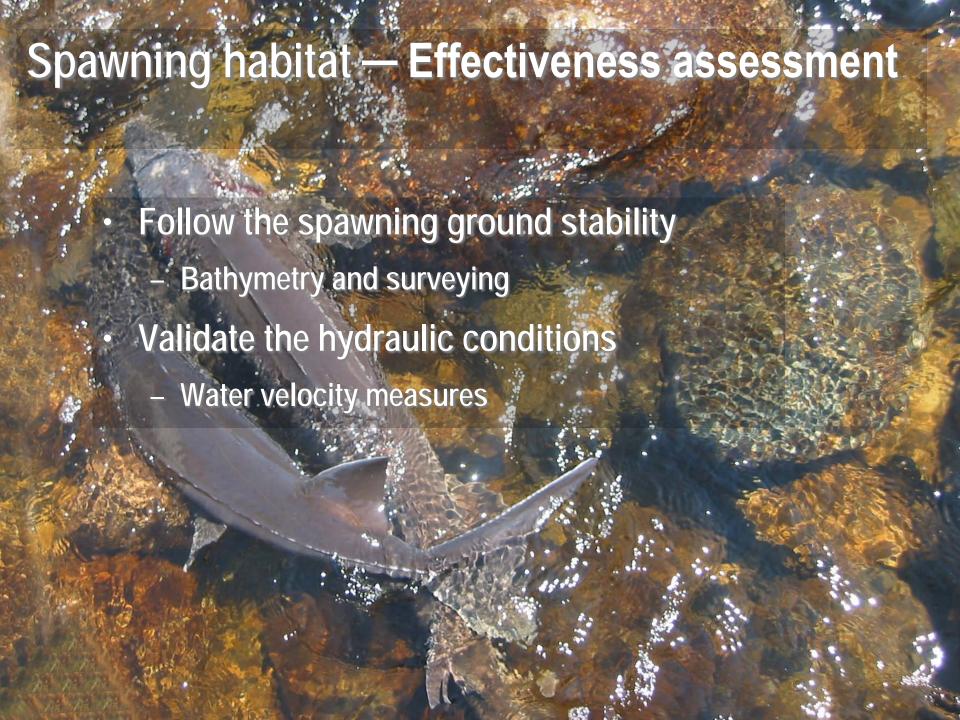
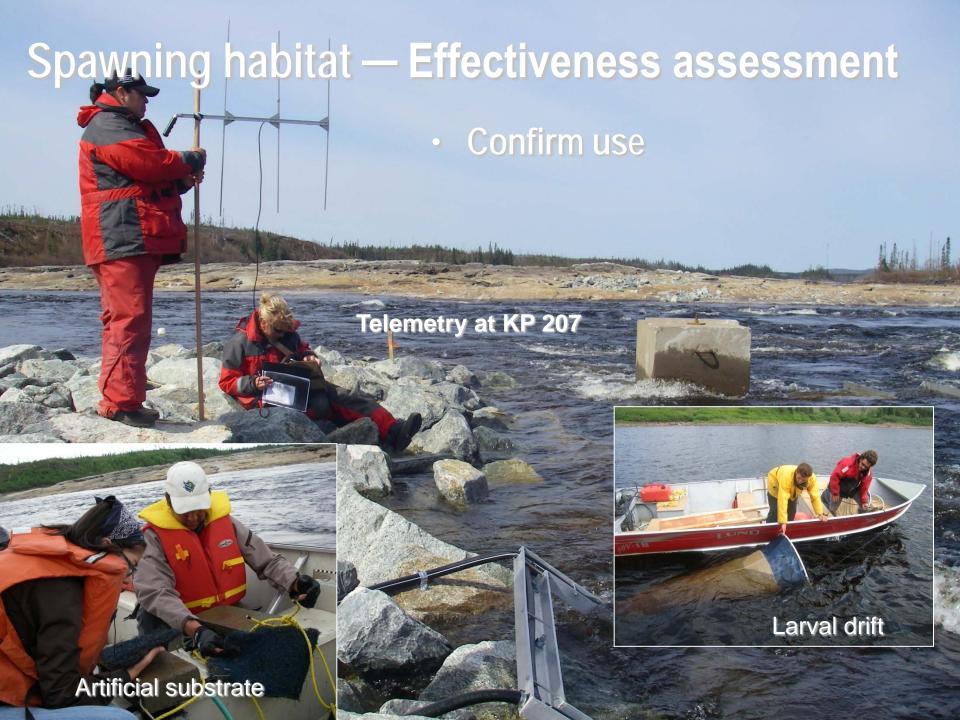
Spawning ground construction

2 000 m²

Eastmain KP 207

Misticawissish KP 35

500 m²

- Stability: Minimal material movement
- ***Adequate spawning conditions at KP 207
- Spawning activity
 - Use of KP 207 site 2 years after construction
- Larval drift
 - One year comparable to natural conditions
 - Three years lower than natural conditions
