# Shaft Coatings

## Preventing Corrosion on Horizontal Hydro Turbines

Chuck DeVane

December 3, 2008

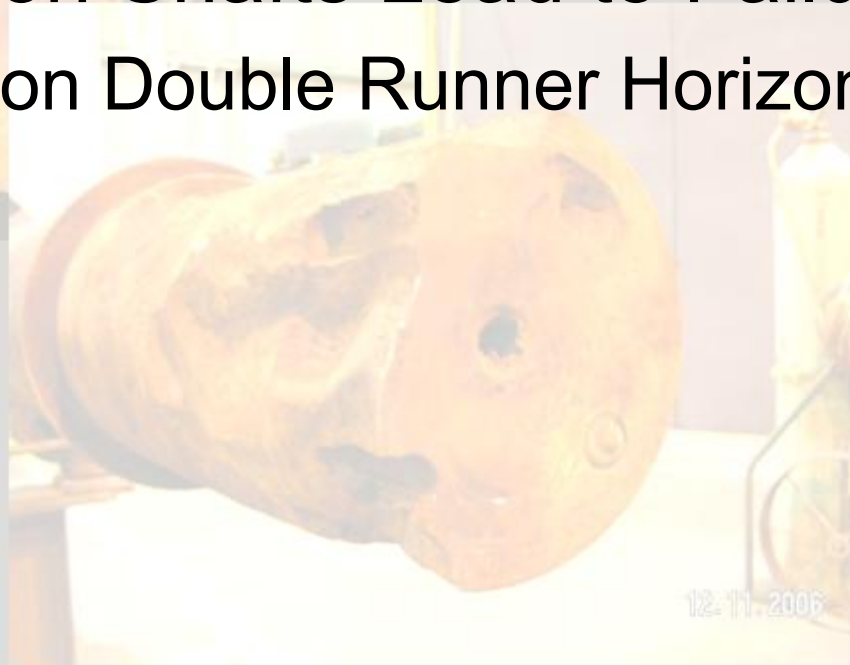
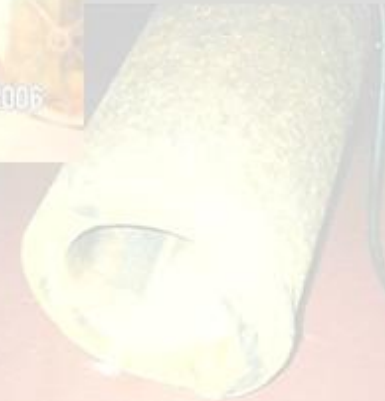
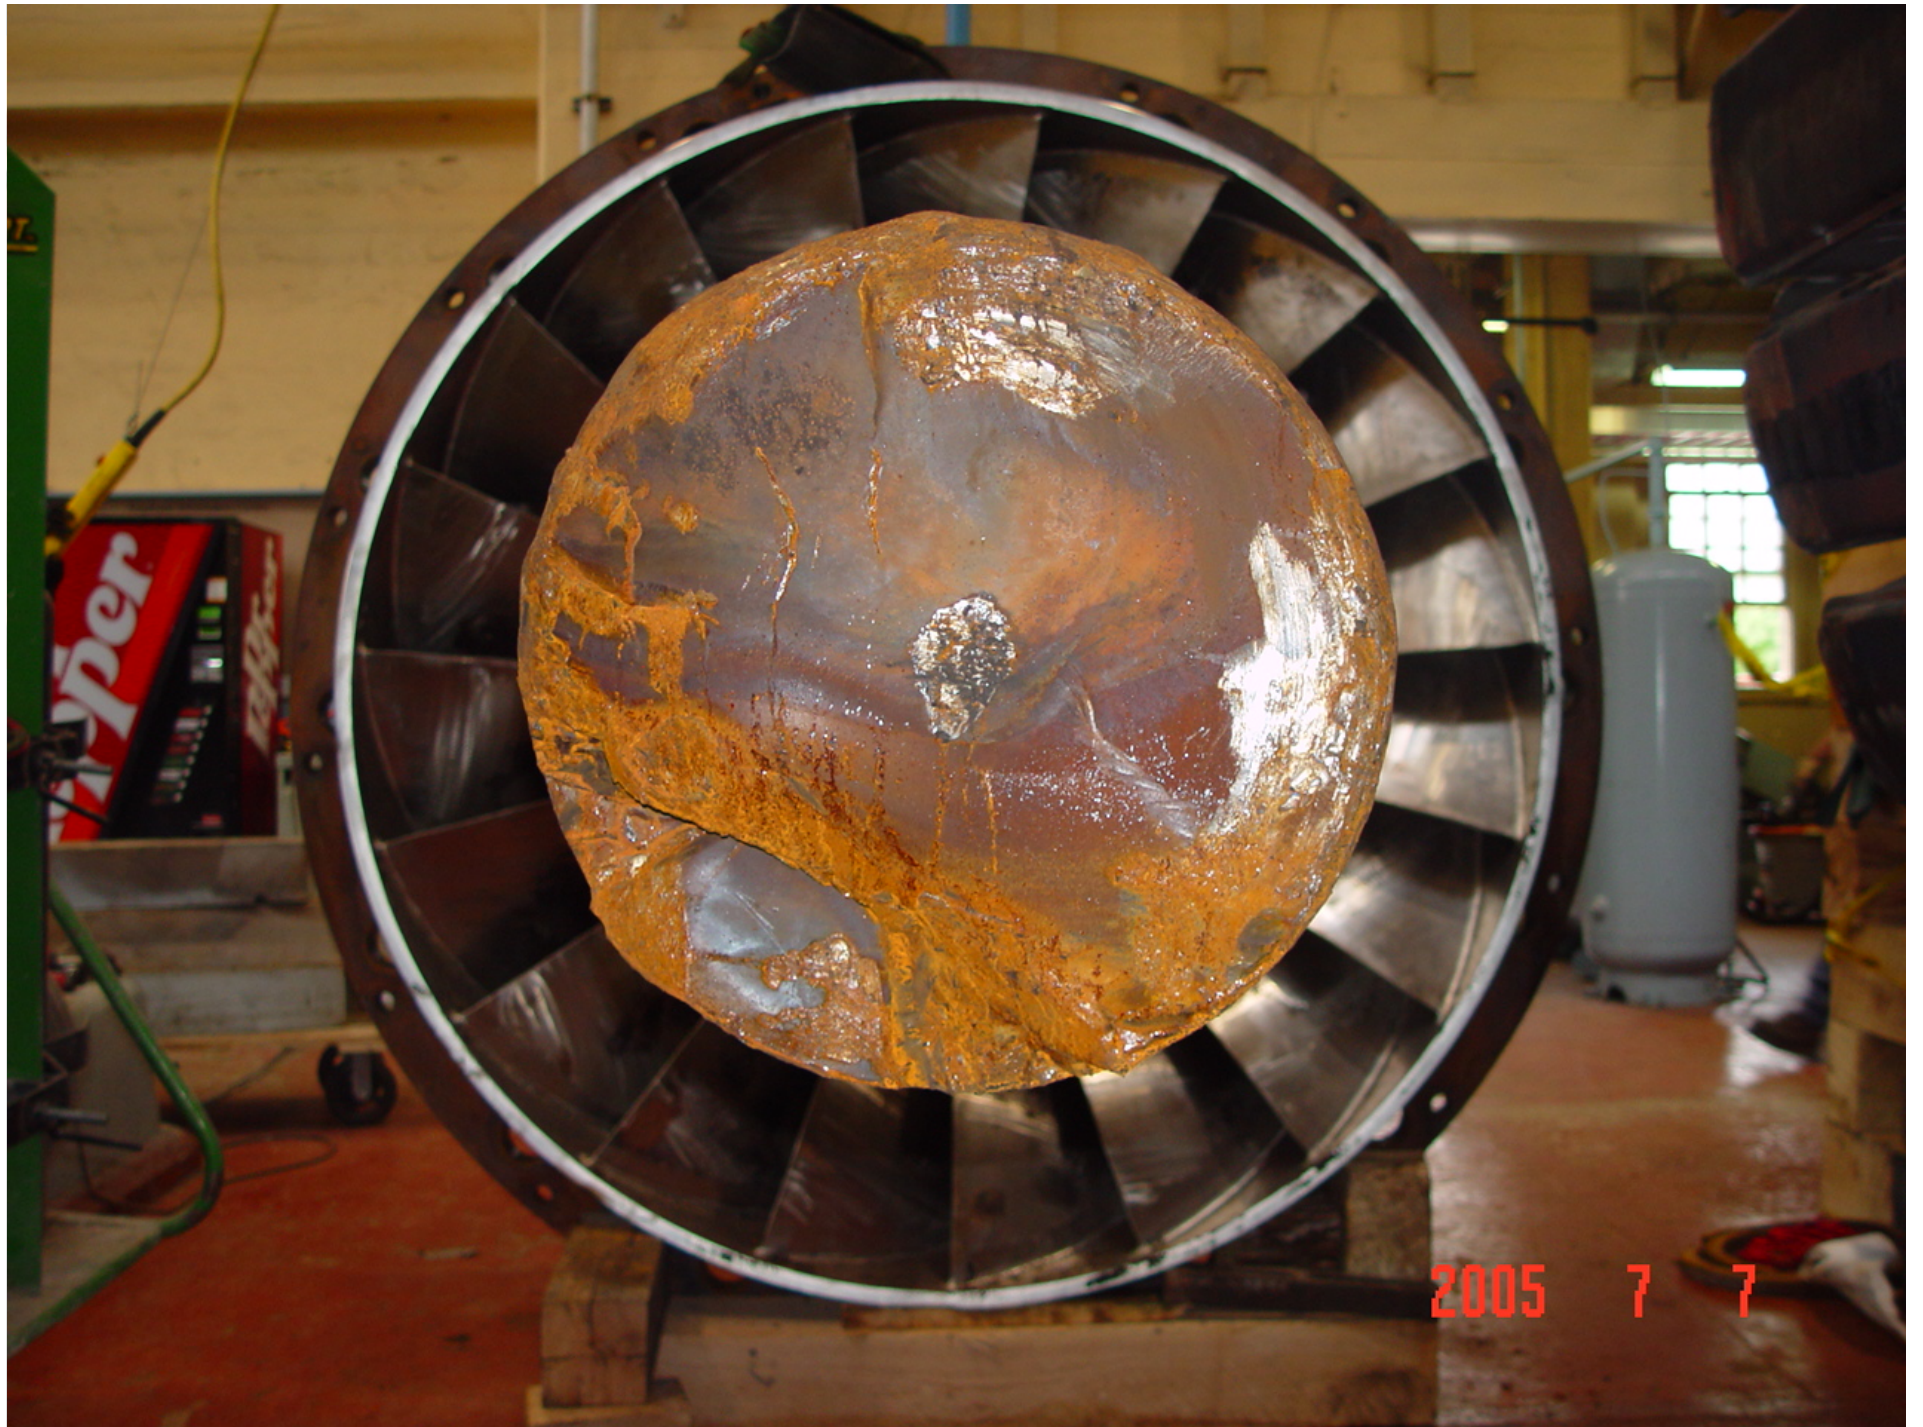
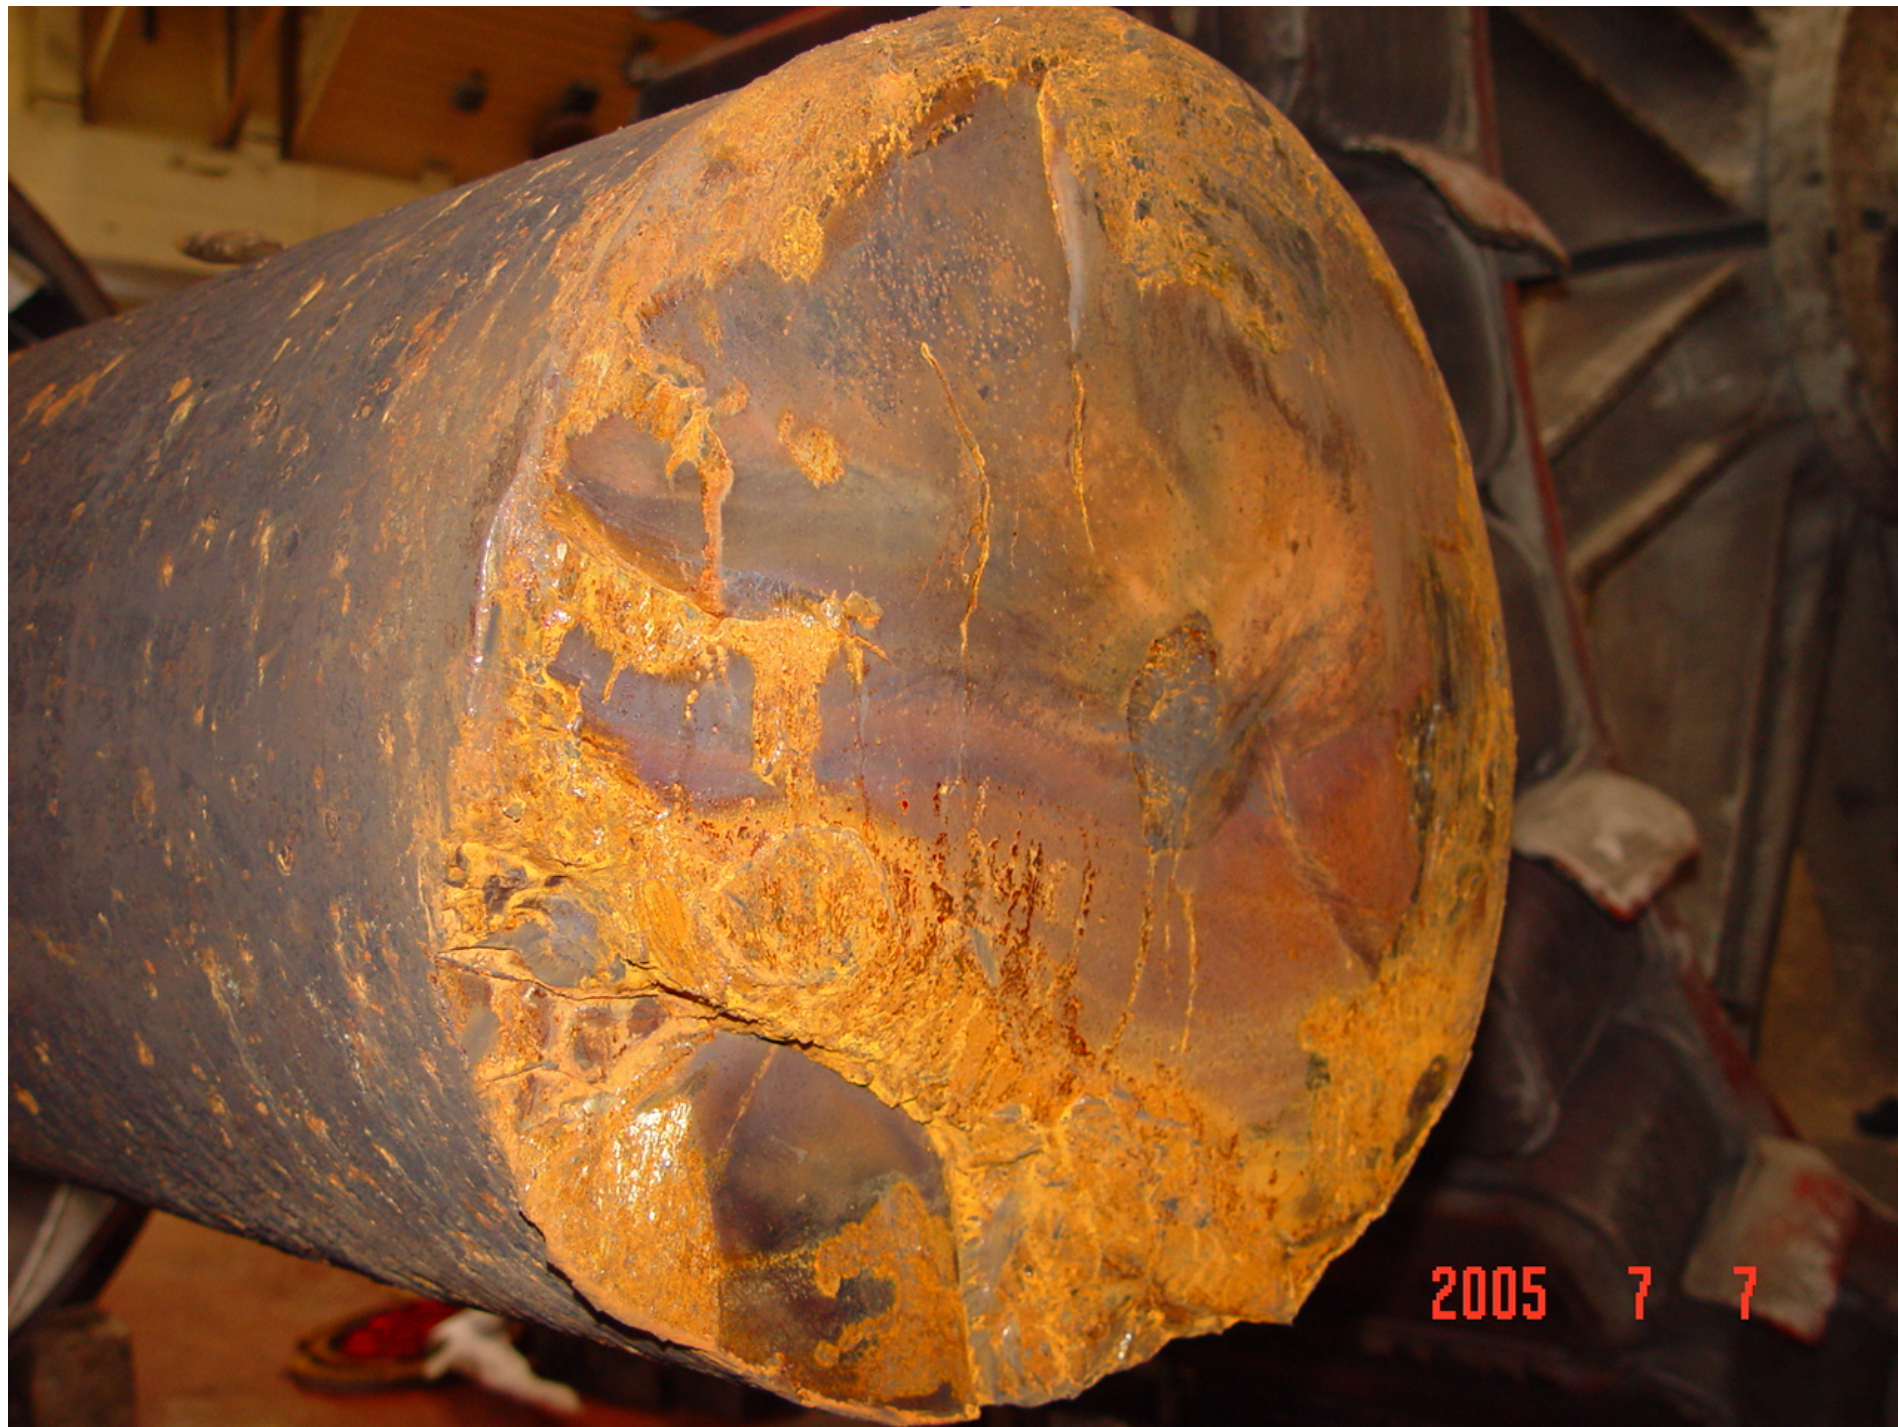
- Corrosion on Shafts Lead to Failures
  - Primarily on Double Runner Horizontal Units

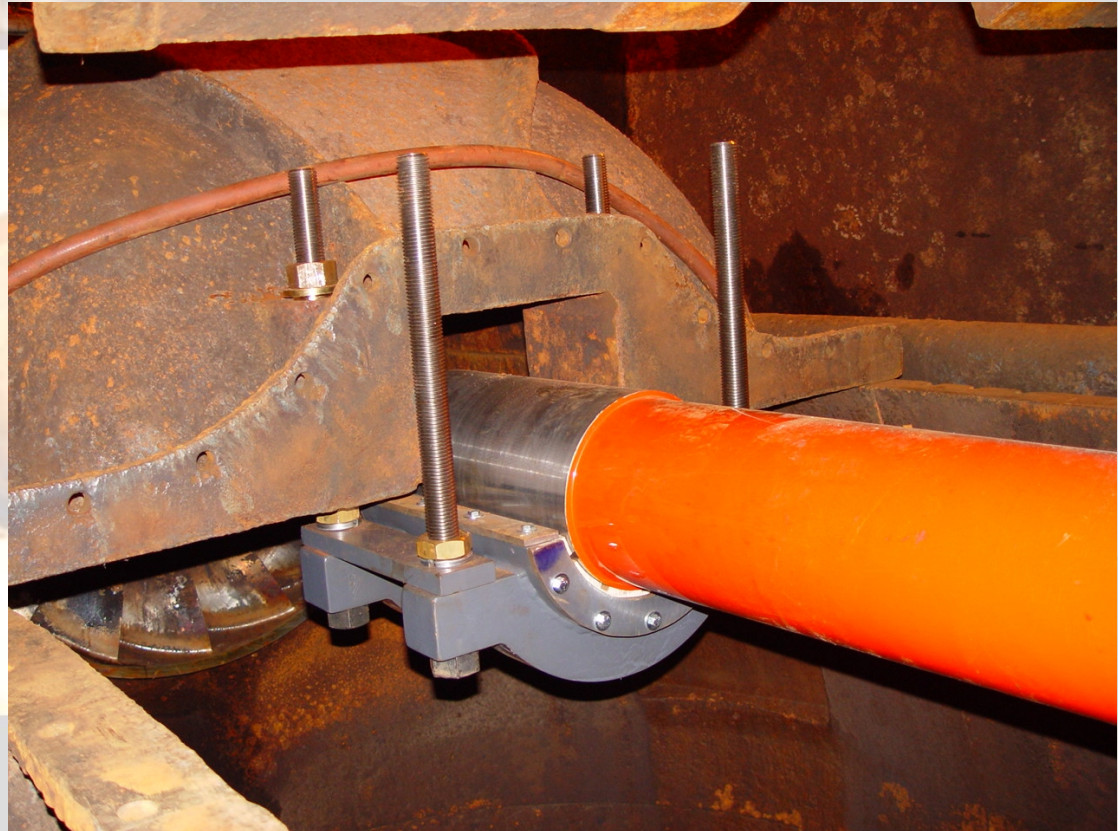
# Lloyd Shoals

- Polyurethane paint
- Applied in 2000/2001
- DID NOT WORK

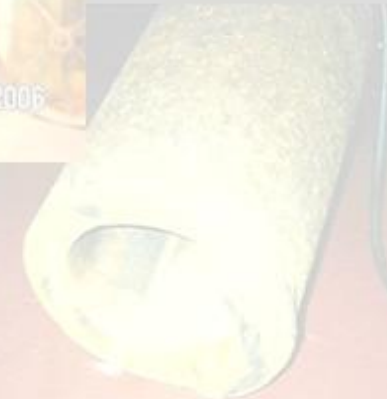
# Goat Rock U3

- Epoxy Paint
  - Often used as primer
  - Rated for immersion service
  - Per turbine vendor, performed well in P/T spiral case
- DID NOT WORK
  - Installed early 2006
  - Recently inspected - gone

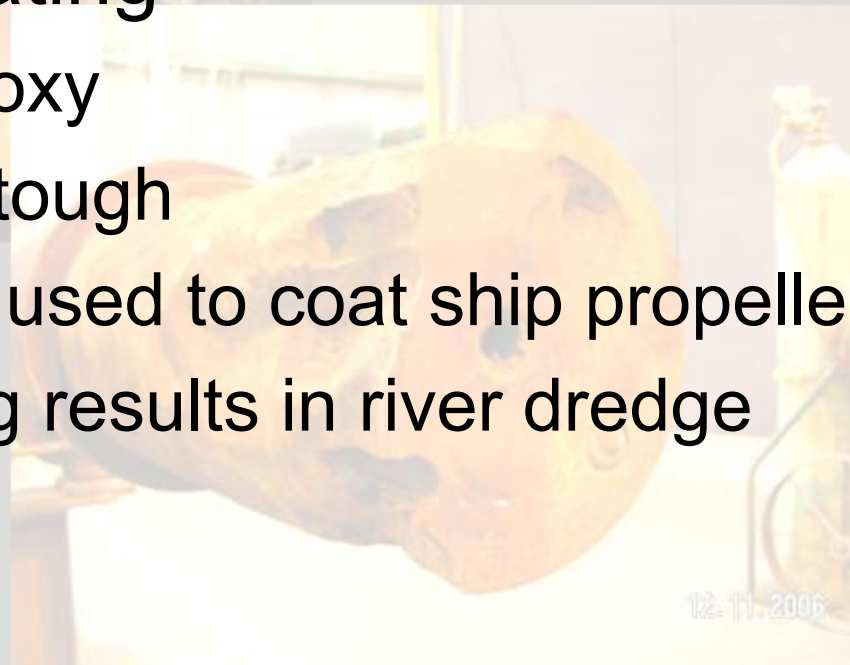
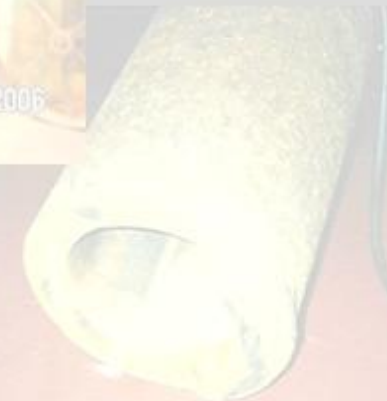
# Morgan Falls U3

- Epoxy Coating
  - 2 part epoxy
  - Flexible, tough
  - Normally used to coat ship propeller shafts
  - Promising results in river dredge

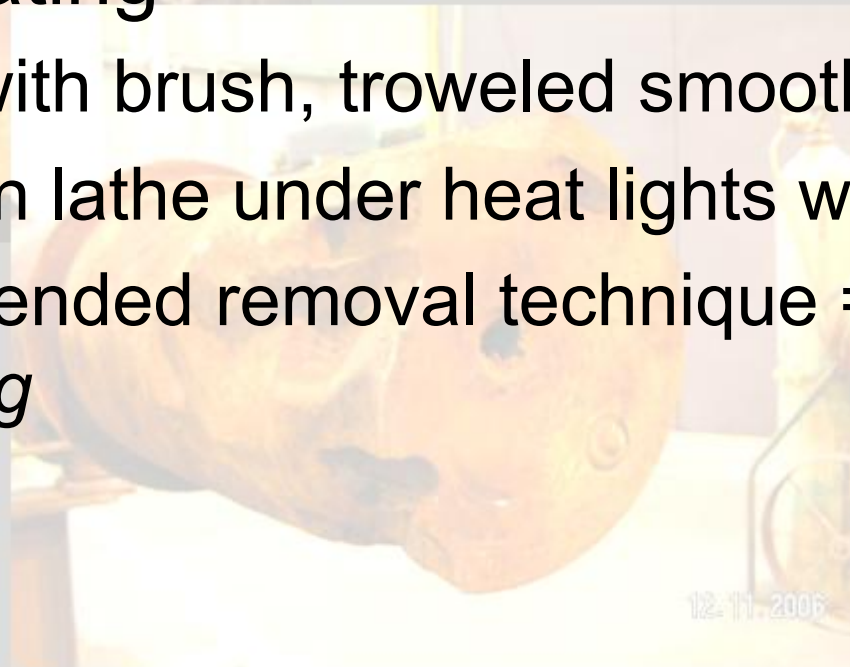
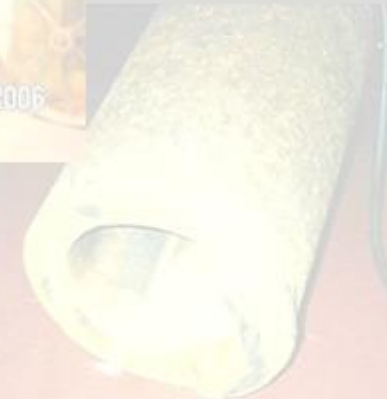
# Morgan Falls U3

- Epoxy Coating
  - Applied with brush, troweled smooth
  - Turned on lathe under heat lights while curing
  - Recommended removal technique = *machining*
